WASTE WATER TREATMENT PLANT AND INCINERATOR COMPLEX,
SITES 5EP2447 AND 5EP2446,
FORT CARSON, COLORADO

James Schneck
and
Karin M. Roberts

United States Department of the Interior
National Park Service
Midwest Archeological Center
Lincoln, Nebraska

September 1998

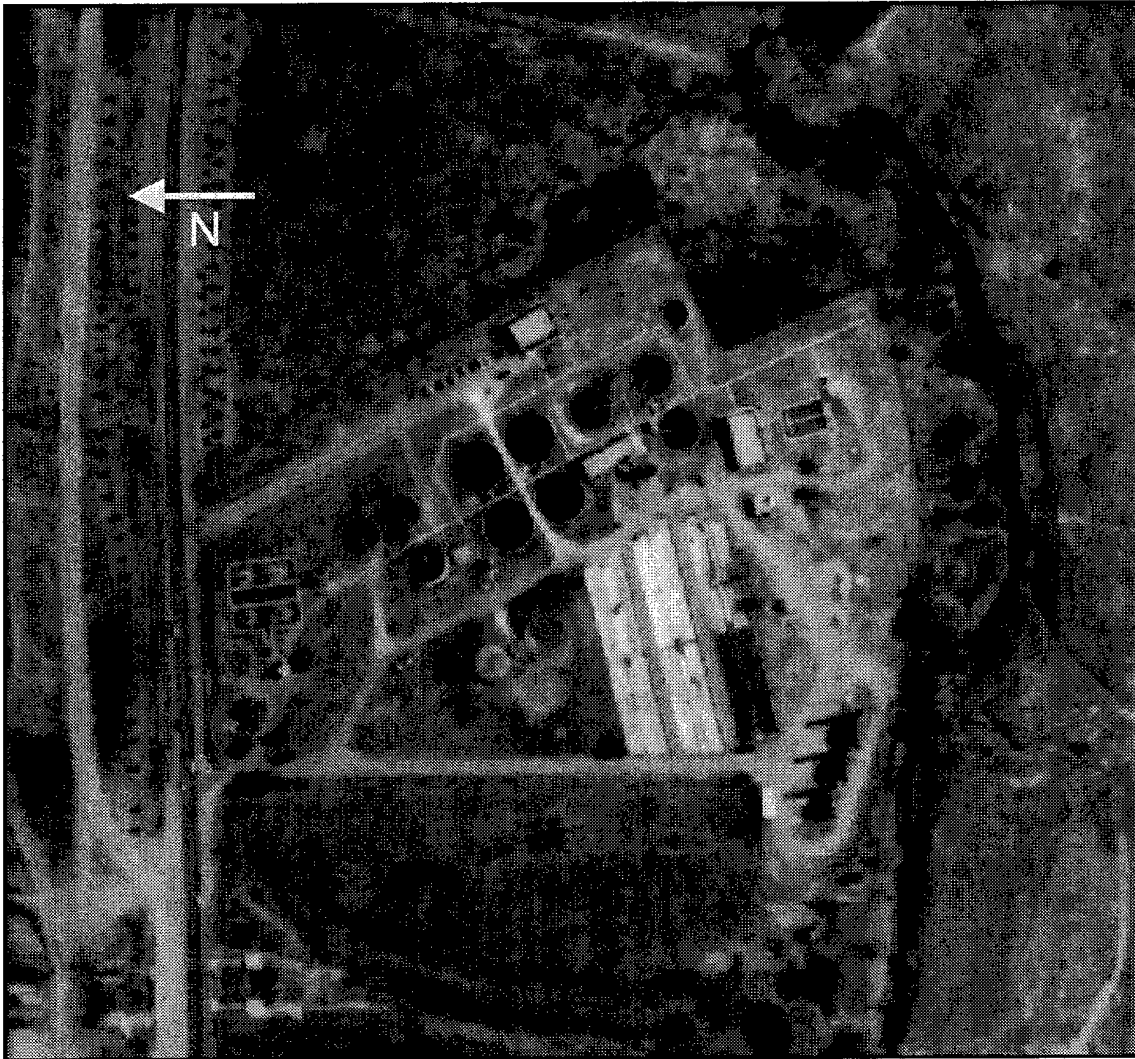
Figure I-1. Aerial Photo of Fort Carson Waste Water Treatment Plant and Incinerator Complex.

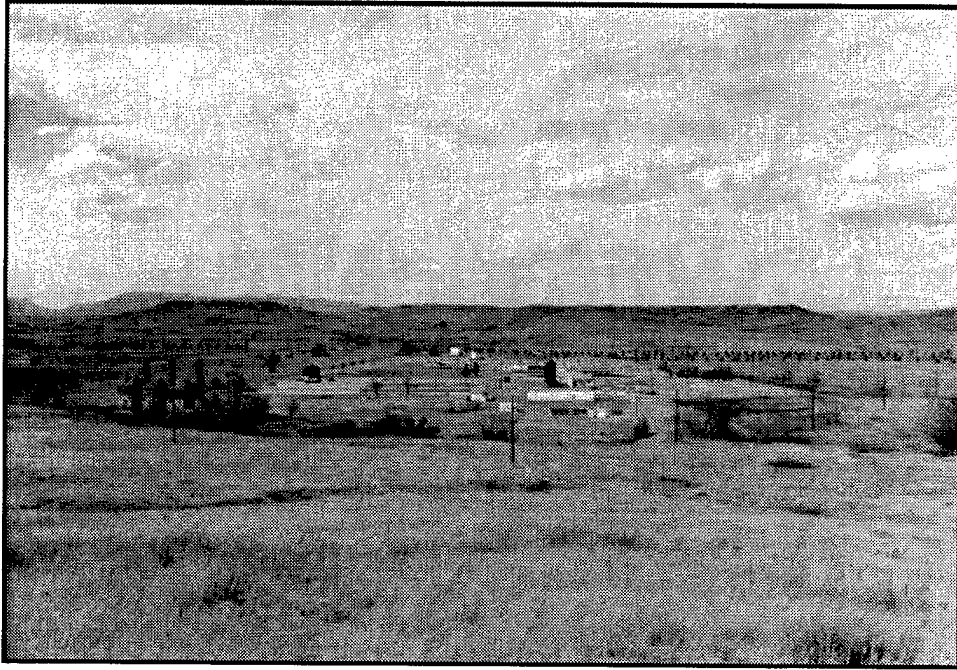
Figure I-2. Overview Photograph of Waste Water Treatment Plant. View to the north. Roll MWAC2, Exposure 20.

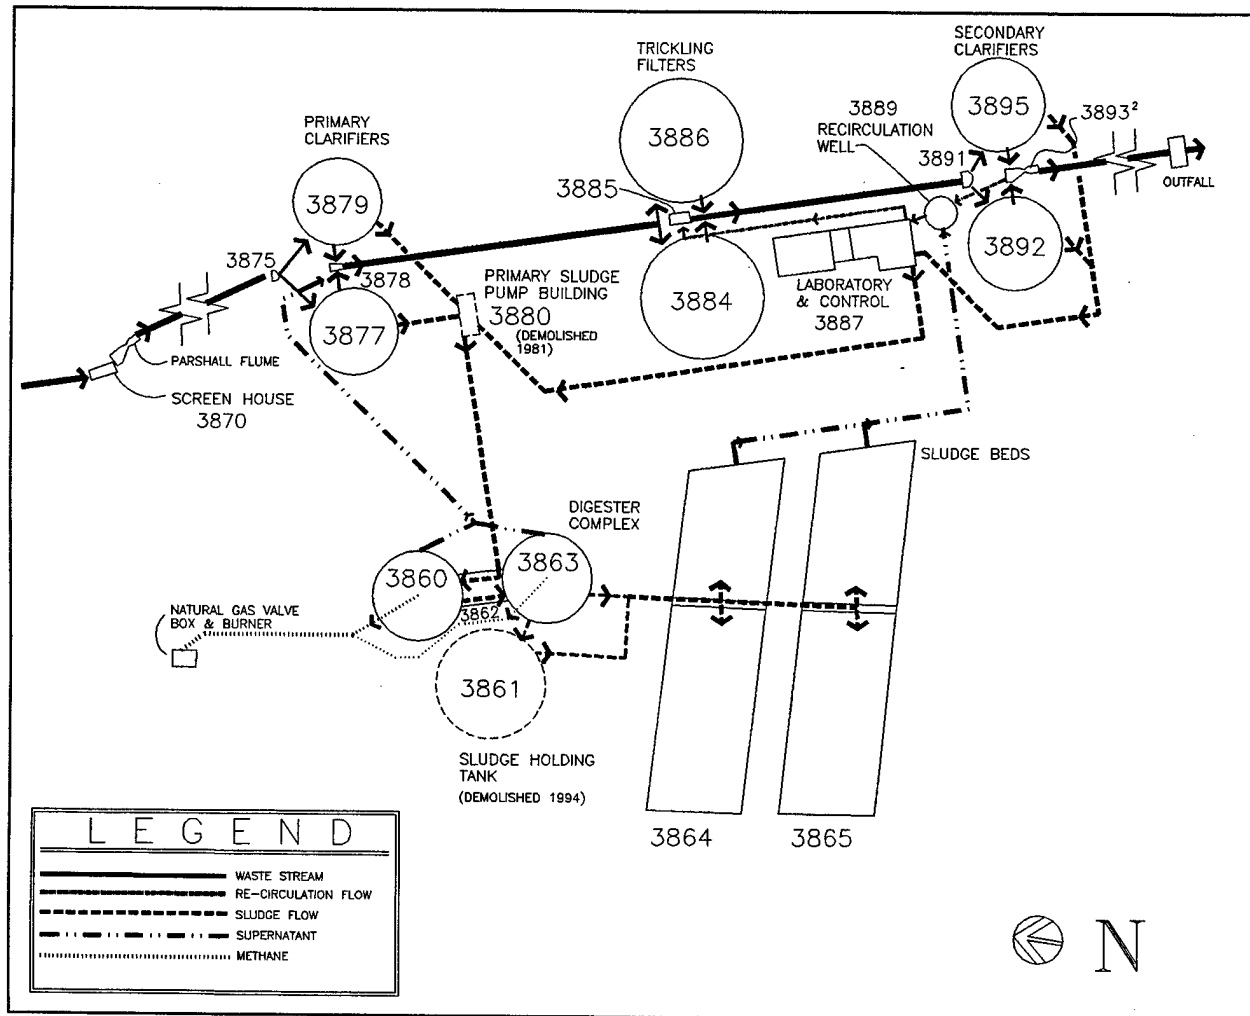
Figure II-2. Single-Phase Trickling Filter Plant Flow Diagram.

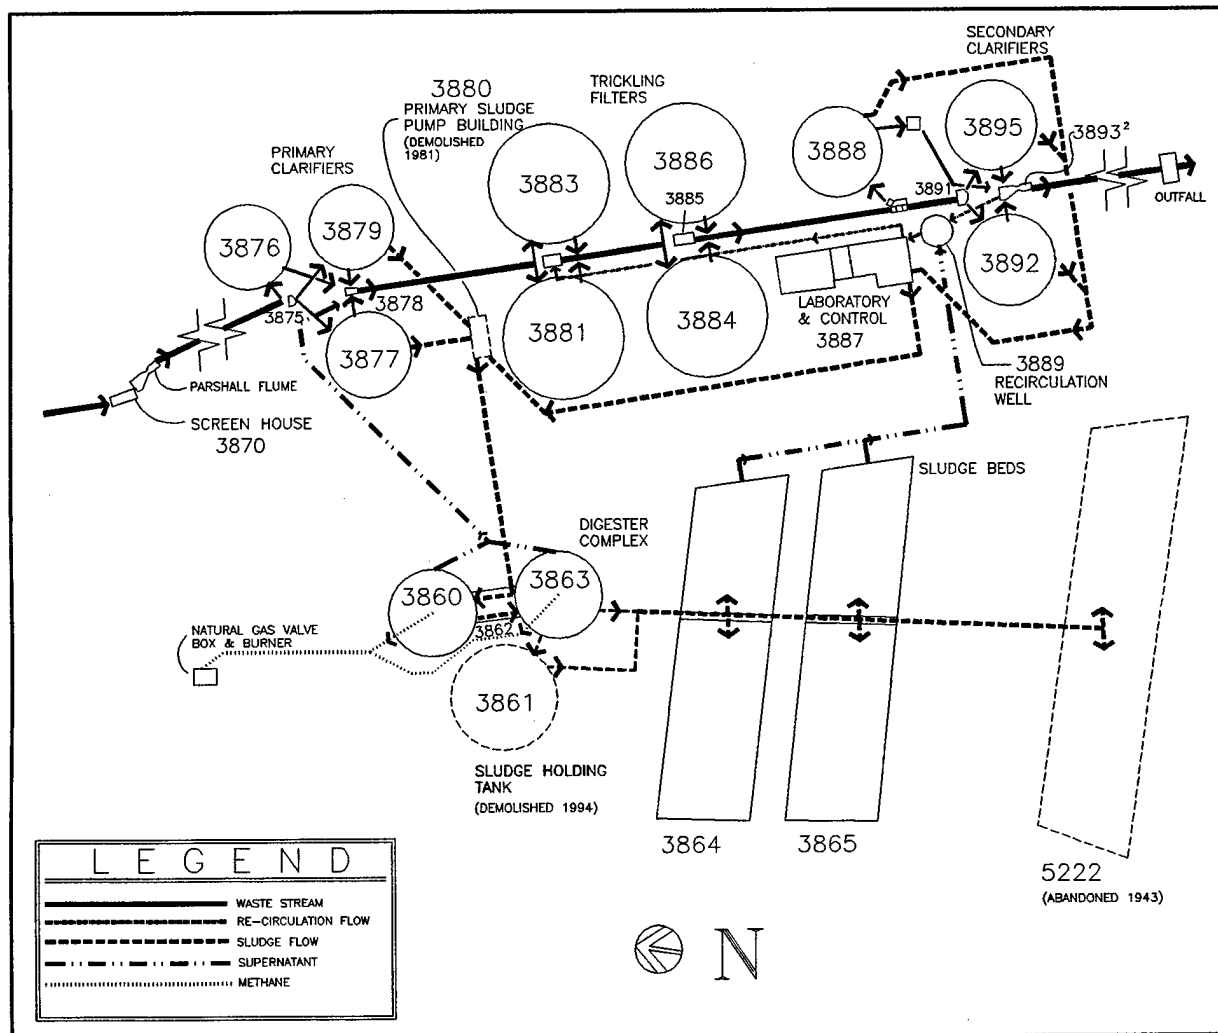
Figure II-3. Two-Phase Trickling Filter Plant Flow Diagram.

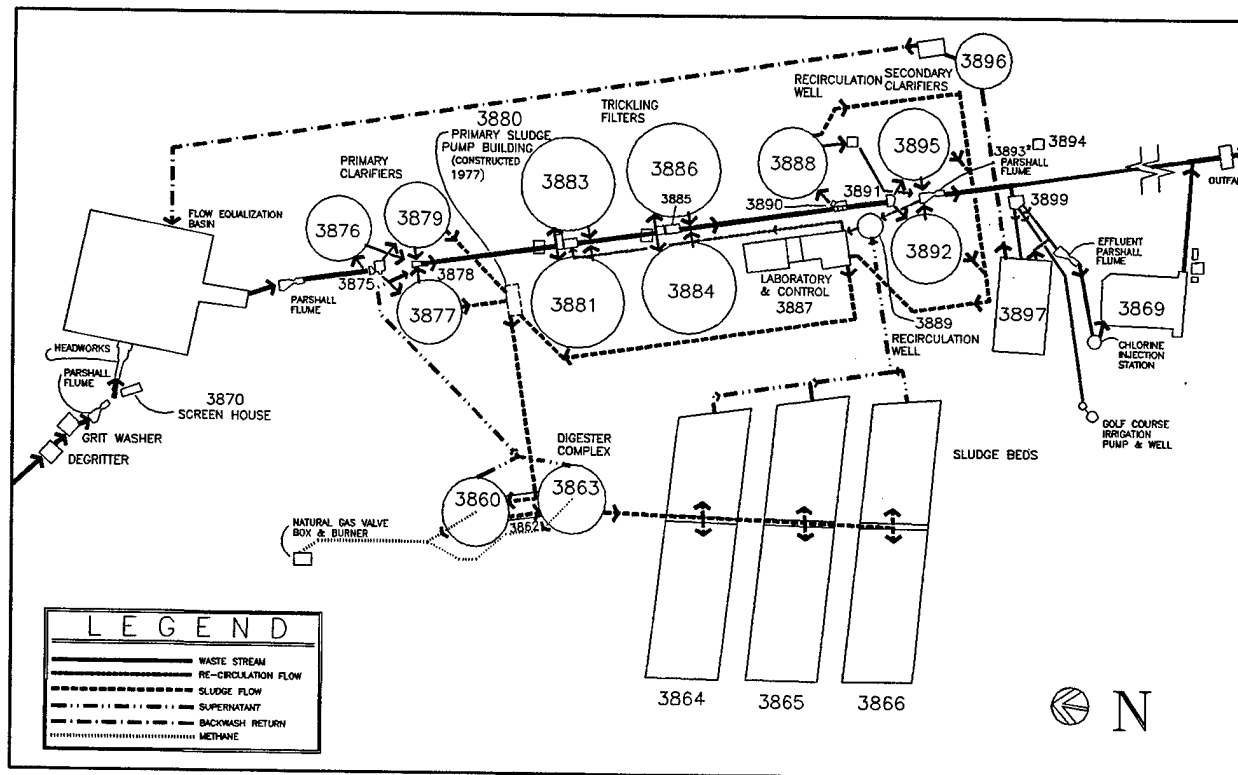
Figure II-4. Three-Phase Trickling Filter Plant Flow Diagram.

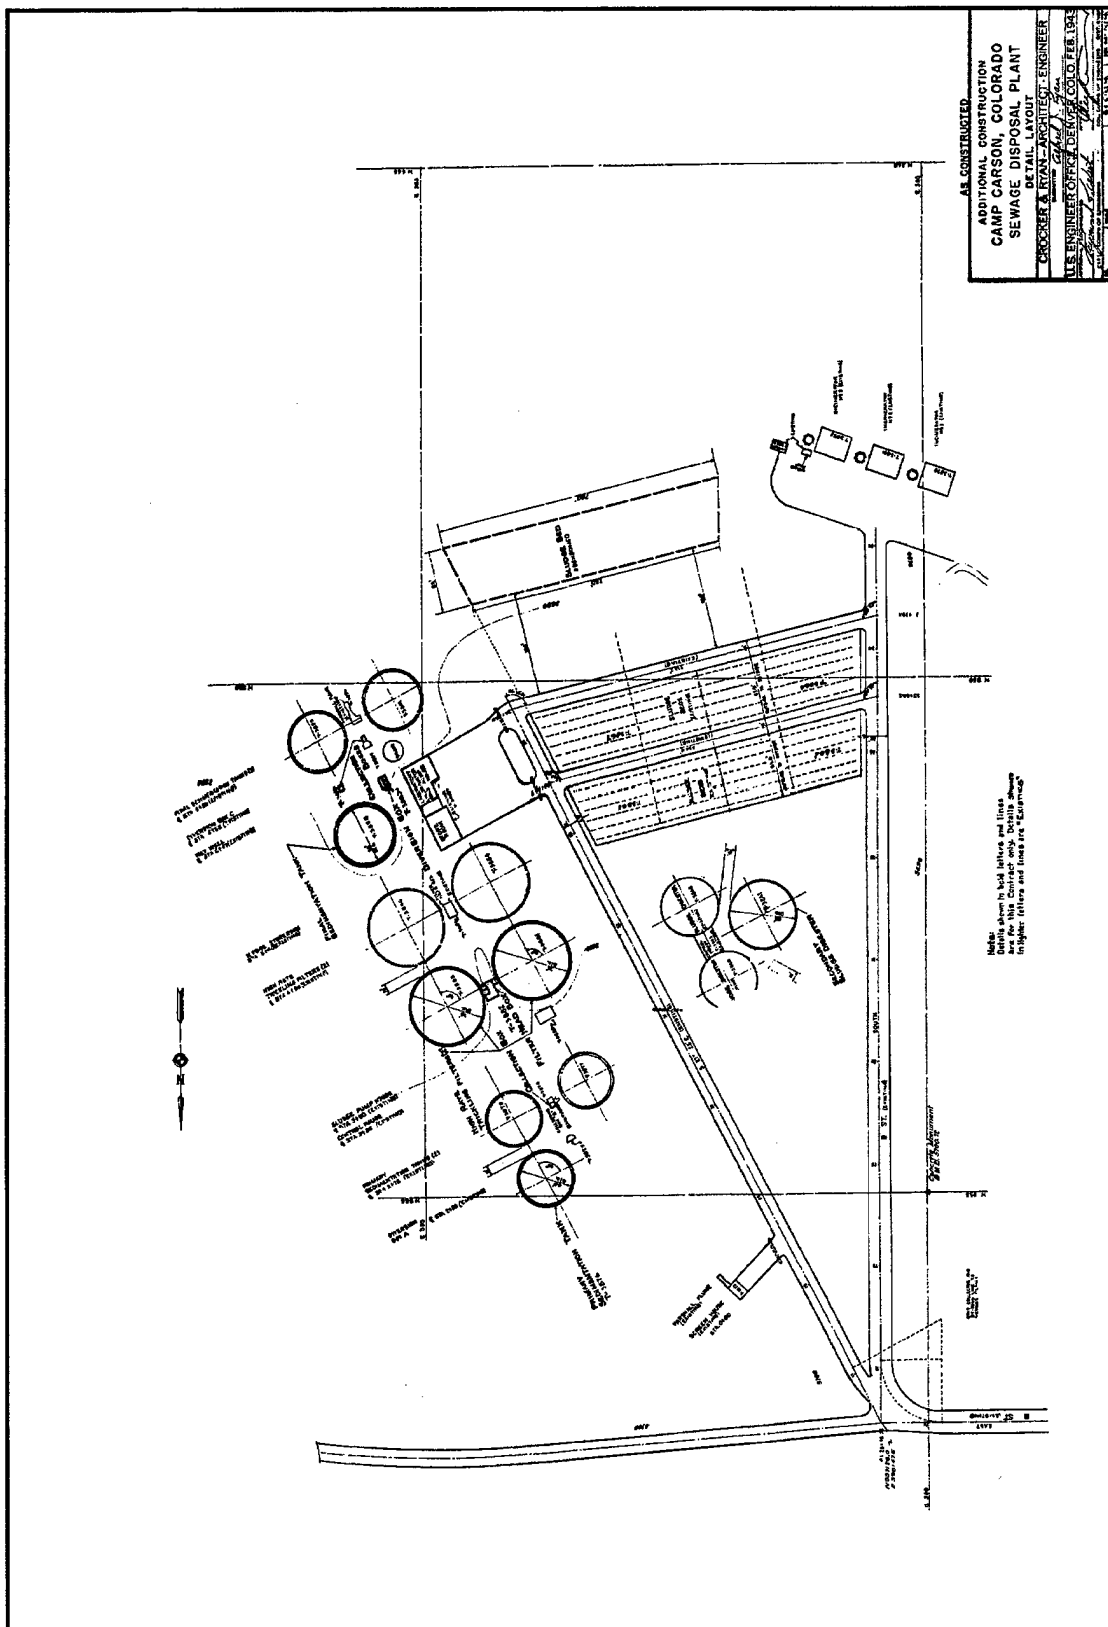
Figure II-5. 1943 Site Plan. Detail Layout for Additional Construction at Camp Carson Sewage Disposal Plant. Plan CCA-2-1. Note original construction in light lines, 1943 additions in dark.

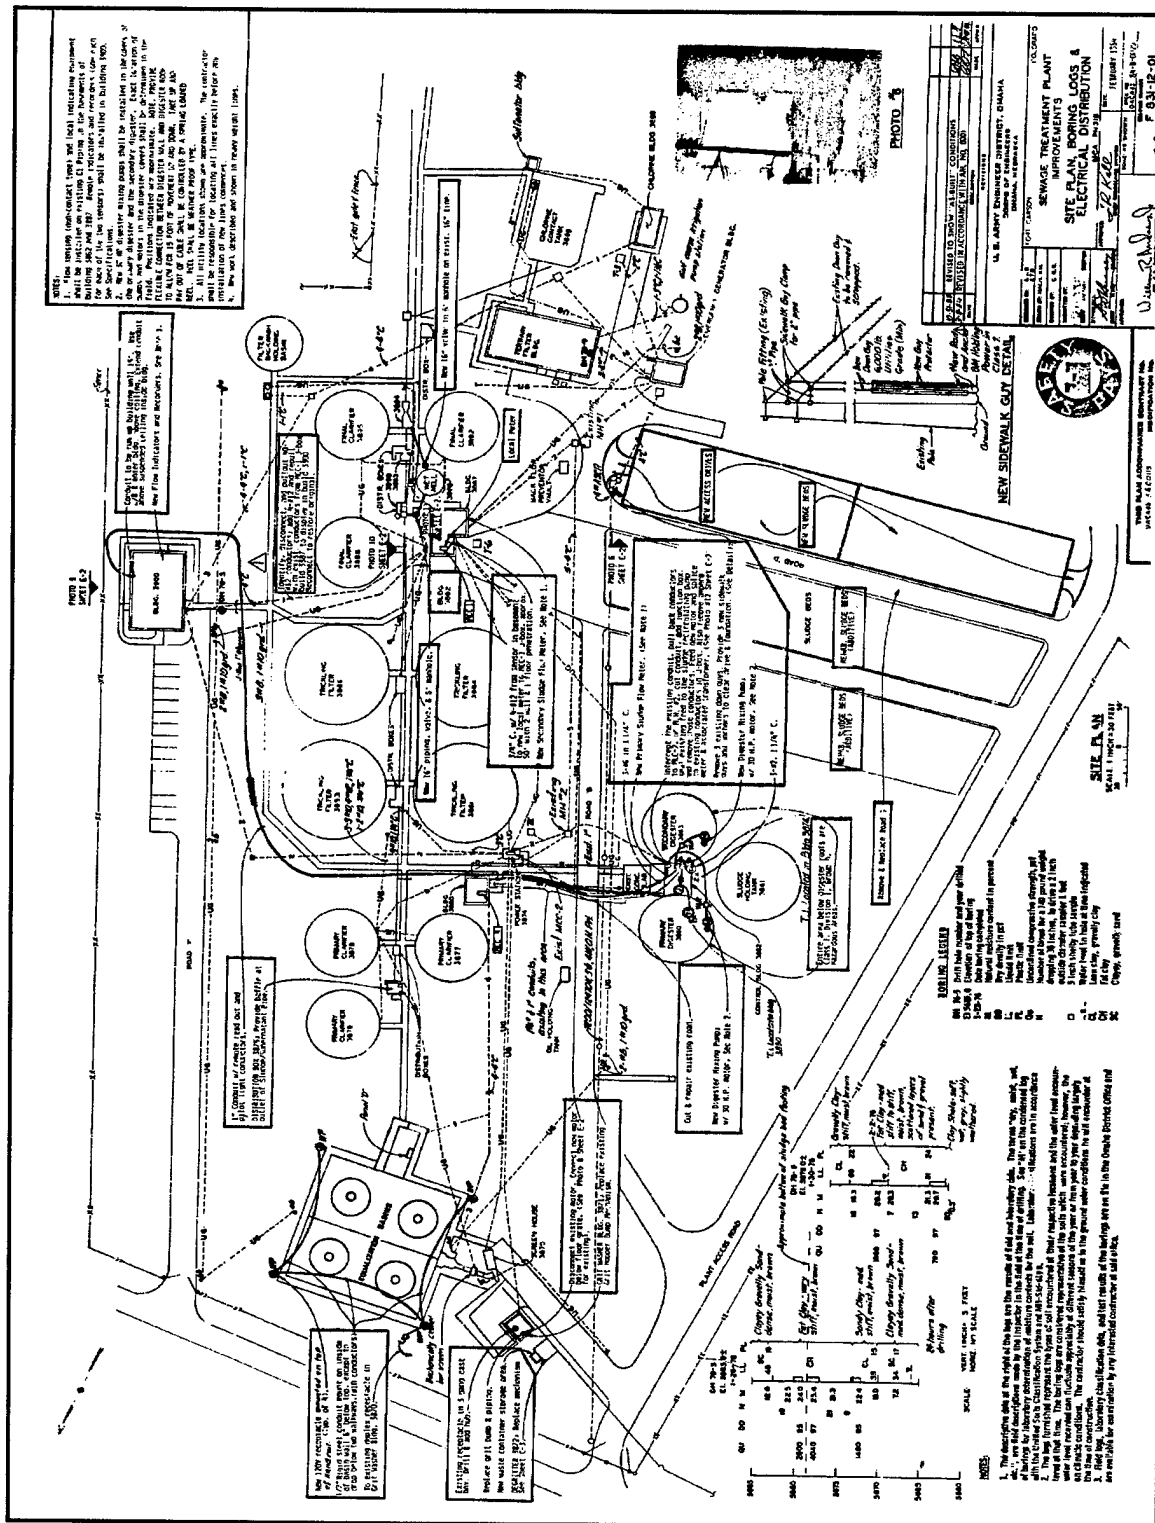
Figure II-8. 1985 Site Plan. Sewage Treatment Plant Improvements - Site Plan, Boring Logs, and Electrical Distribution. Plan F 831-12-01, Sheet C-2.

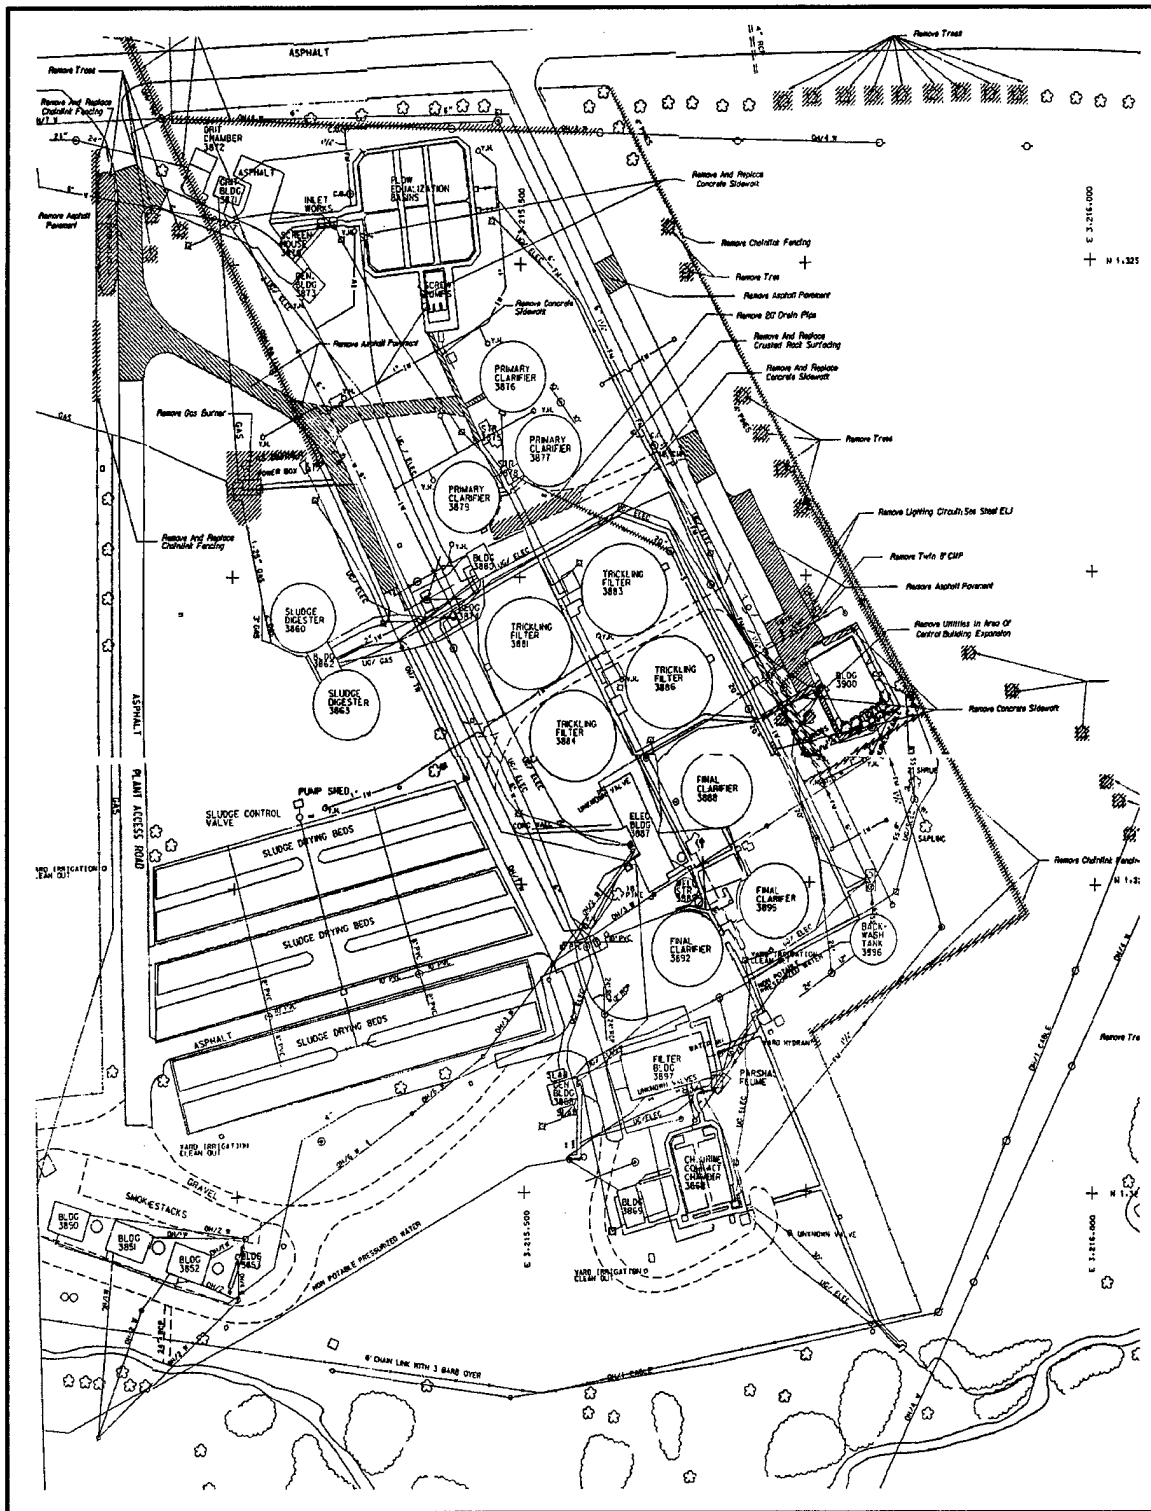
Figure II-9. 1995 Site Plan. Removal Plan - Waste Water Treatment Plant (WWTP) Upgrade. Plan 871-75-05, Sheets P2.1 and P2.2, Areas A and B.

Incinerator Lavatory 3853 originally housed a shower and lavatory for incinerator workers. The building later housed a generator before being demolished in 1995 (Figure II-9). All that remains today is a concrete floor and foundation.

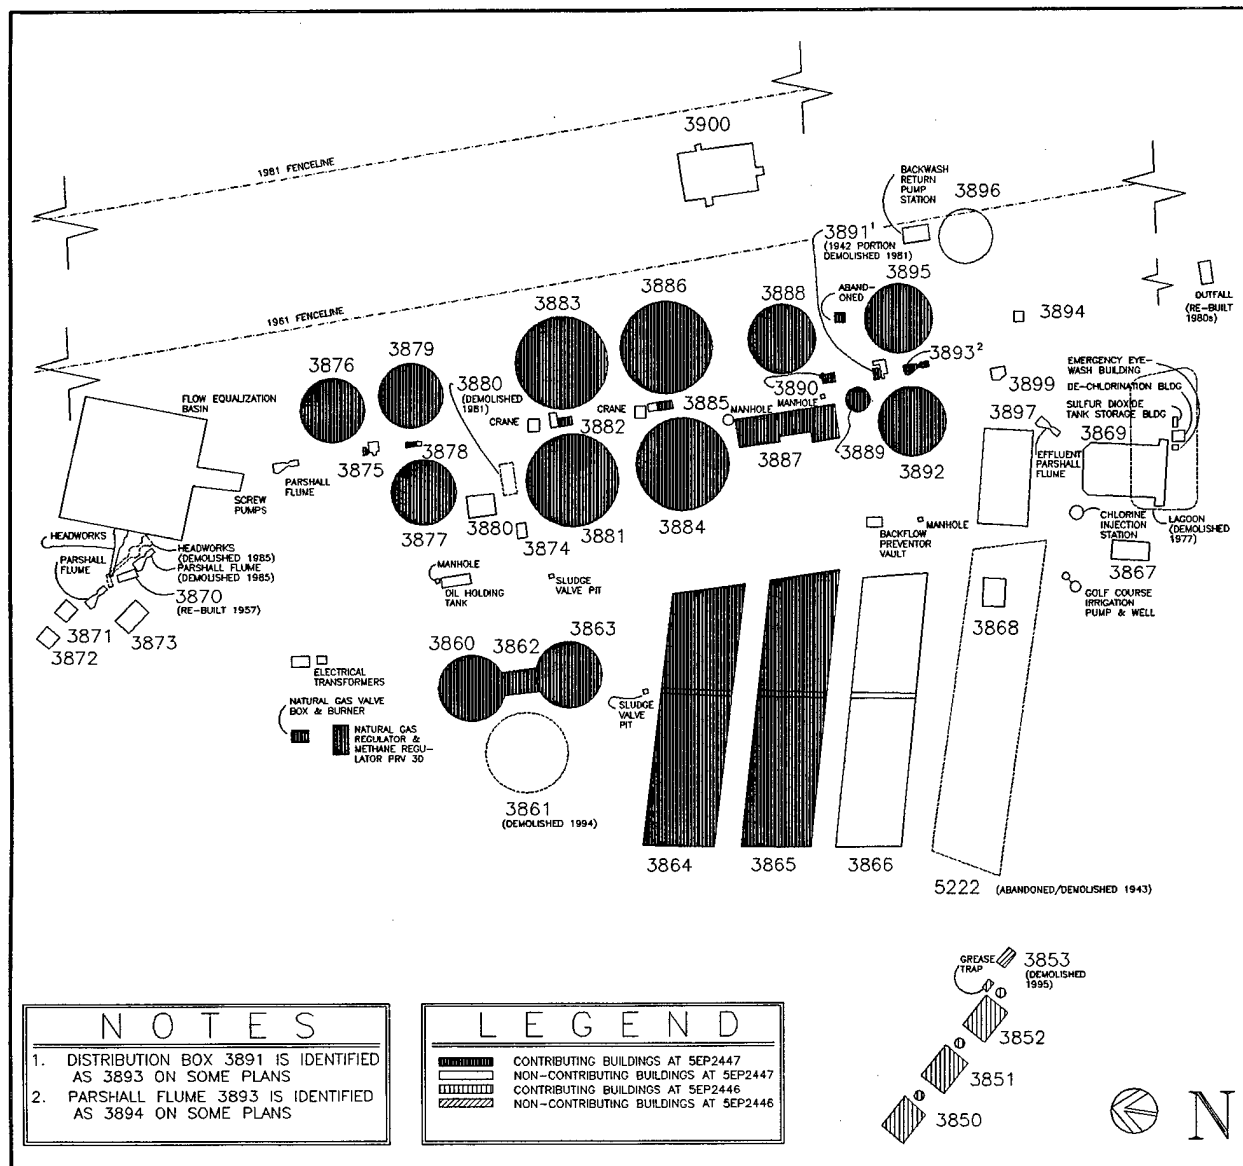
Figure II-10. Site Plan for contributing and non-contributing buildings at the Waste Water Treatment Plant and Incinerator Complex.

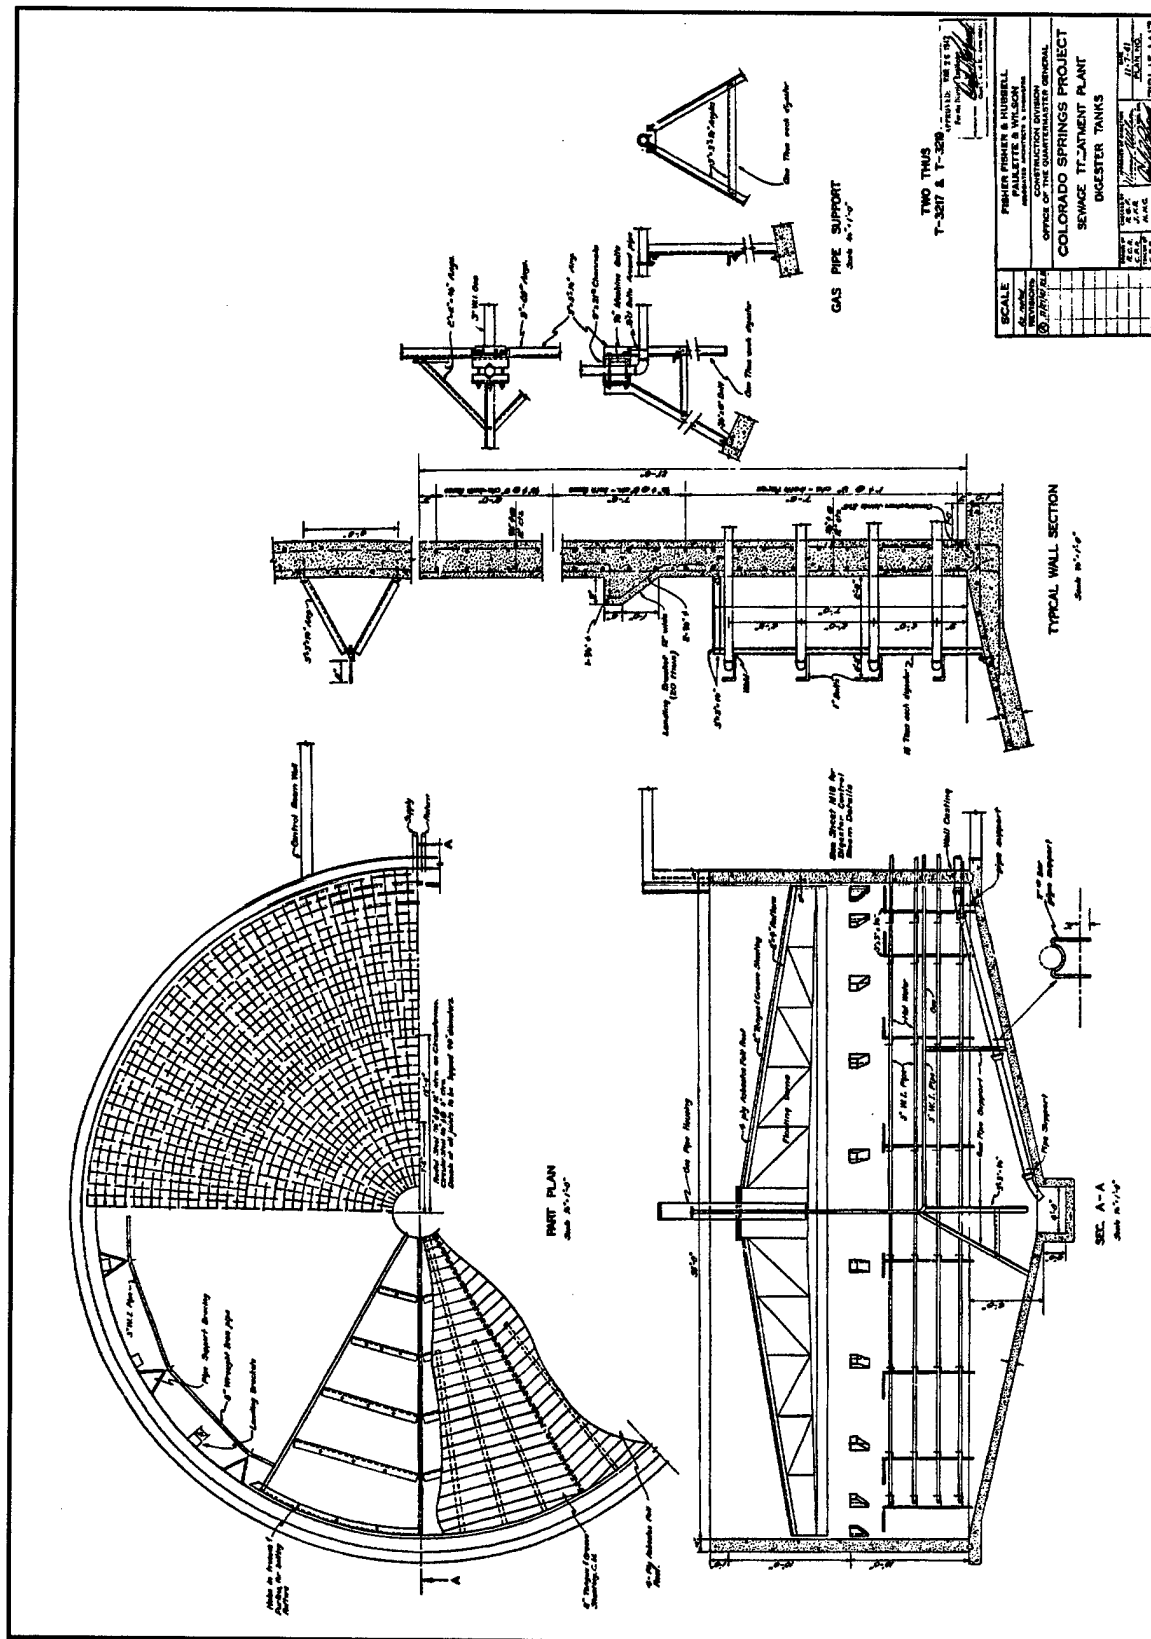
Figure II-11. Plans and sections for Primary and Secondary Digesters 3860 and 3863. Sewage Treatment Plant Digester Tanks. Plan 7131-15-M17 2G.

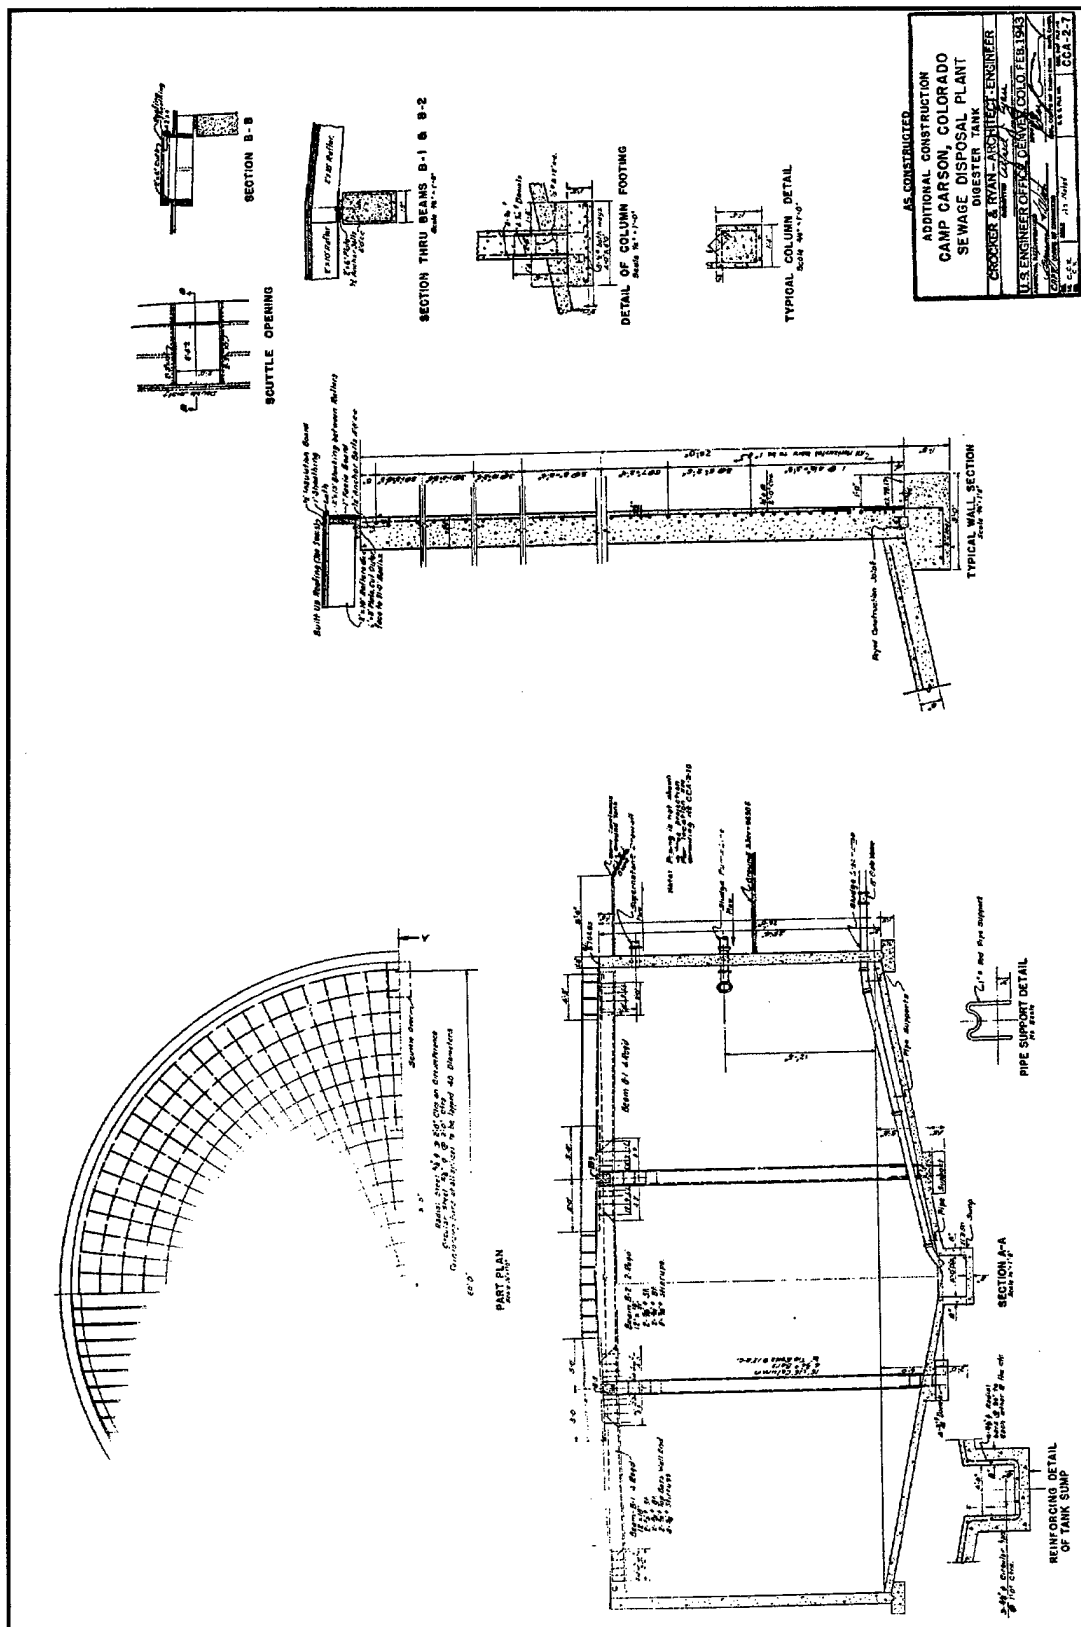
Figure II-12. Plans, sections, and details for Sludge Holding Tank 3861. Sewage Disposal Plant Digester Tank. Plan CCA-2-7 3S.

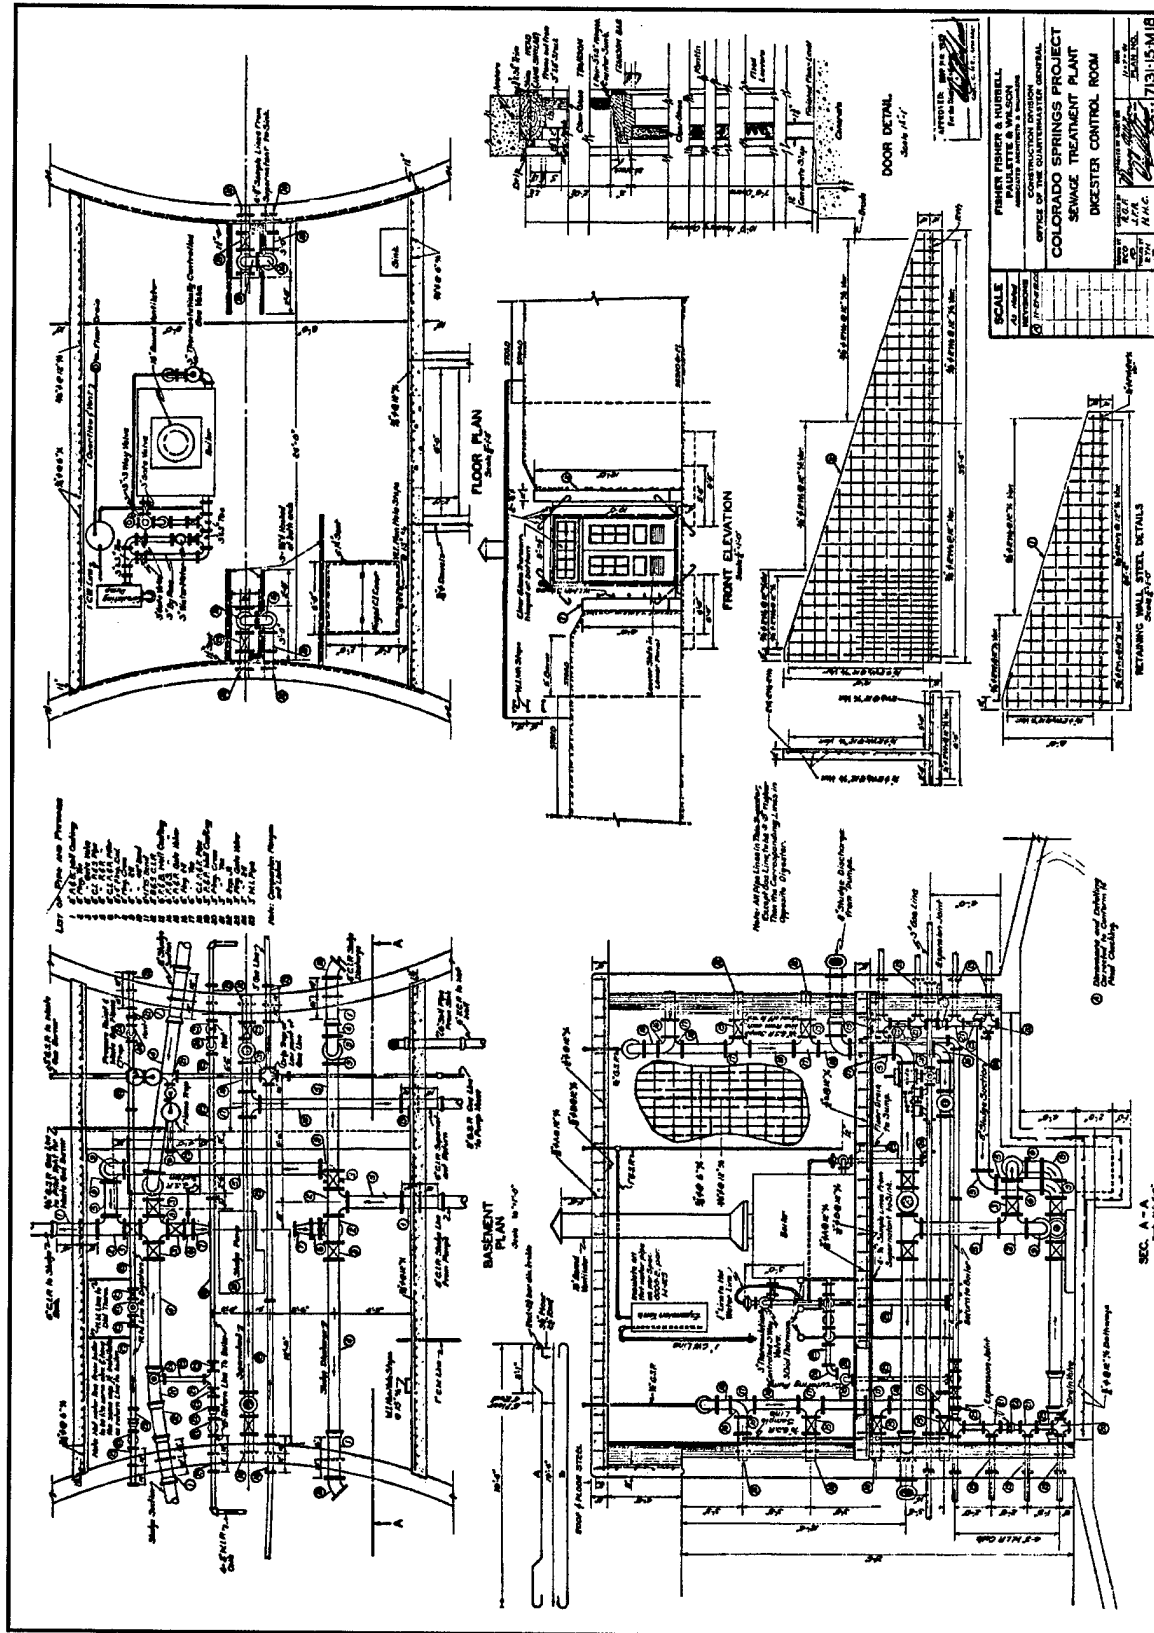
Figure II-13. Plans, elevations, sections, and equipment layouts for Digester Control Room 3862. Sewage Treatment Plant Digester Control Room. Plan 7131-15-M18 2G.

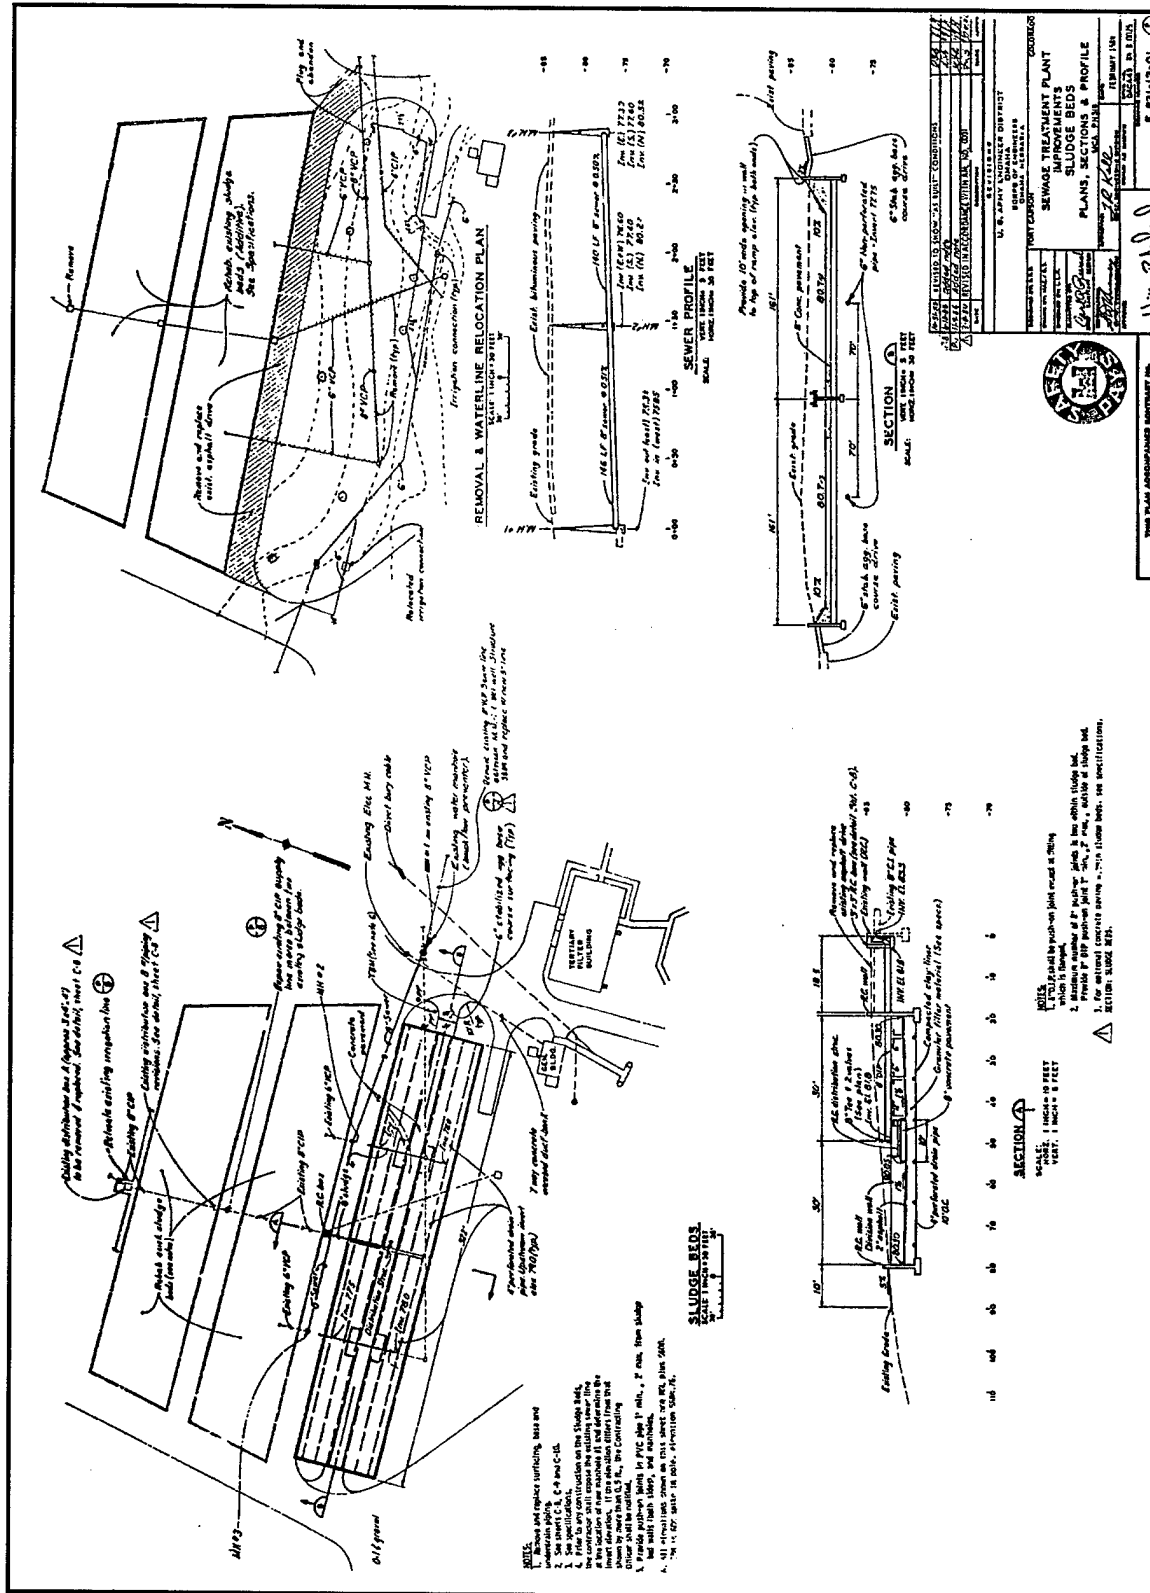
Figure II-15. Plans and sections for Sludge Bed 3866; modifications to Sludge Beds 3864 and 3865. Improvements - Sludge Beds - Plans, Sections and Profile. Plan F 831-12-01, Sheet C-7.

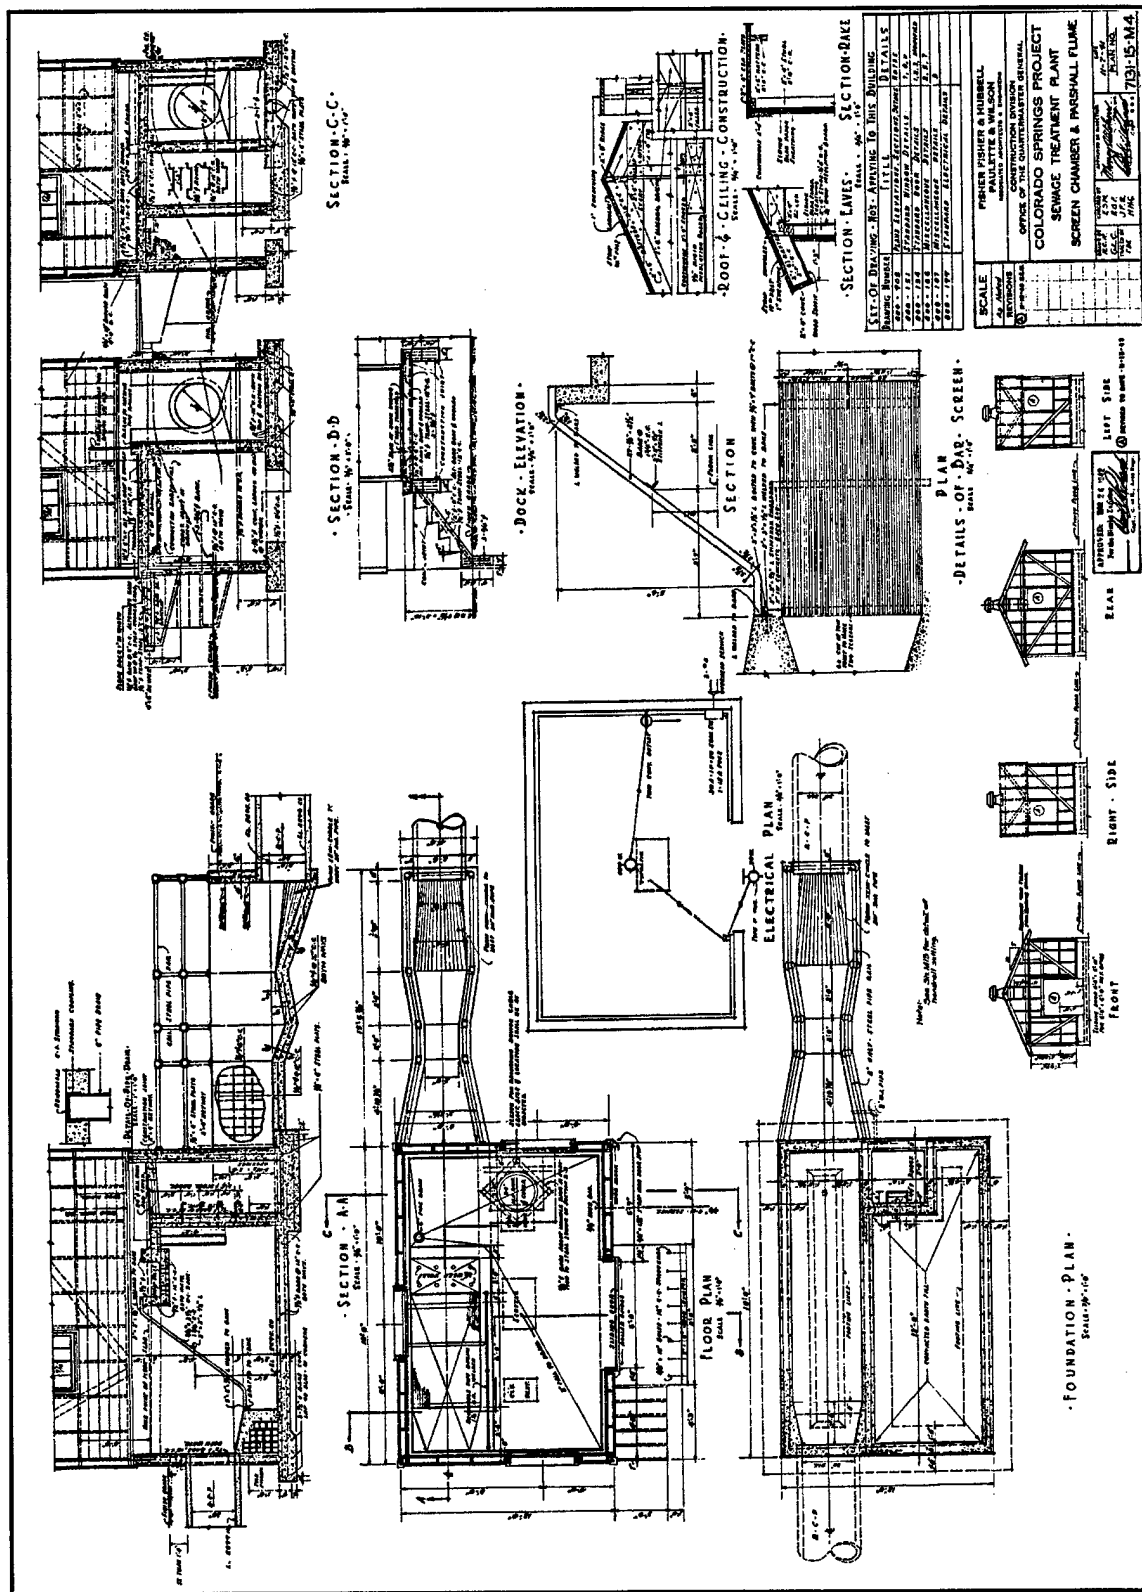
Figure II-16. Plans, sections, and details for Screen House 3870. Screen Chamber and Parshall Flume. Note that Parshall Flume in plan demolished in 1985. Plan 7131-15-M4 2G.
